Massachusetts Historical Commission
80 Boylston Street
Boston, Massachusetts 02116

Address 4 Corey Road

Style/Form Shingle Style

BUILDING FORM

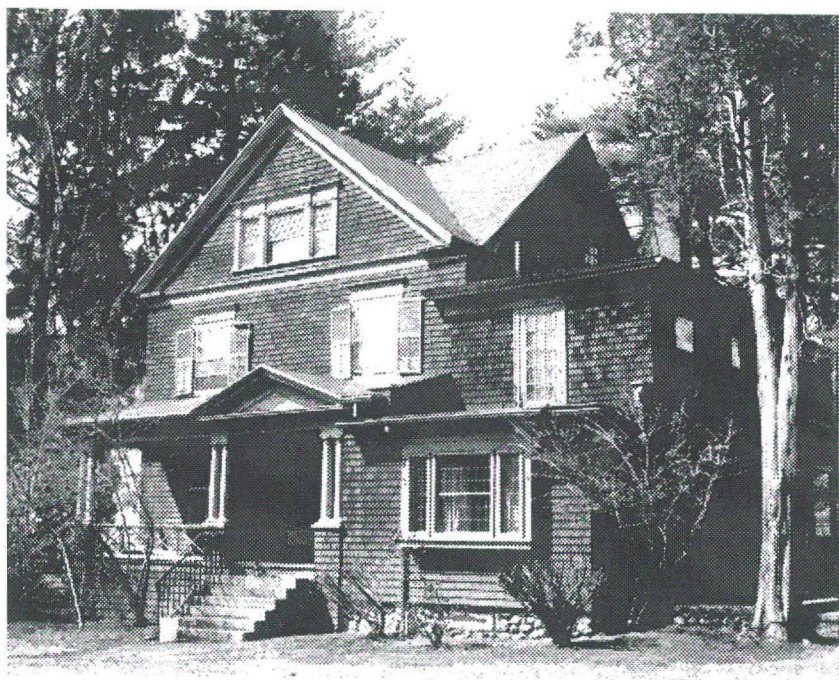
Condition excellent

This house is the best-preserved of the few rare examples of Shingle Style architecture in the Church Street Area. (See also 14/16 Warren Avenue, MHC #611.) Although its square, angular proportions are somewhat more Queen Anne in nature, it has the continuous shingled surfaces, steeply-pitched gabled roofs, and, most notably in the facade gable window, the multiple-unit window, here a triple, with diagonal-paned upper sashes, that characterize the Shingle Style.

This is a 2 1/2-story cross-gabled building with a two-story rear wing. Abutting the north side of the main house is a flat-roofed sleeping porch. In front of it is what appears to be an added flat-roofed room or enclosed porch. The main facade is two bays wide, with a pedimented porch on short paired Tuscan columns on shingled pedestals. Most of the windows are 6-over-1-sash, with molded surrounds and high friezes and dentilated cornices. A single French window appears in the facade of the sleeping porch.
